NBSIR 75-669

Failure of Flexible Brass Gas Appliance Connectors

February 1975

Failure Analysis Report

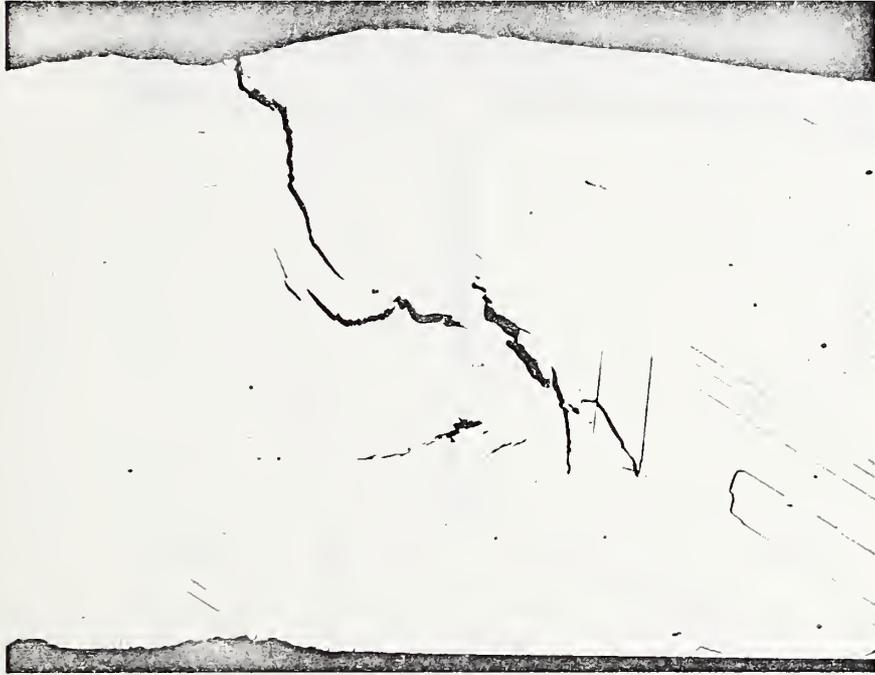
Optical micrographs were made of a specimen which was sectioned from the flexible tubing in an area near one of the major fracture sites. Cracks can be observed throughout the body of the material and are highly branched (Fig. 4). When the specimen surface was chemically etched two important observations can be made: (1) the metal microstructure is of rather large grain size, and (2) the cracks are largely transgranular in nature, propagating through grains rather than through grain boundaries (Fig. 5).

Fig. 4 Optical Micrograph (x200) of a cross section of the flexible brass tubing, showing the branched nature of the cracks.

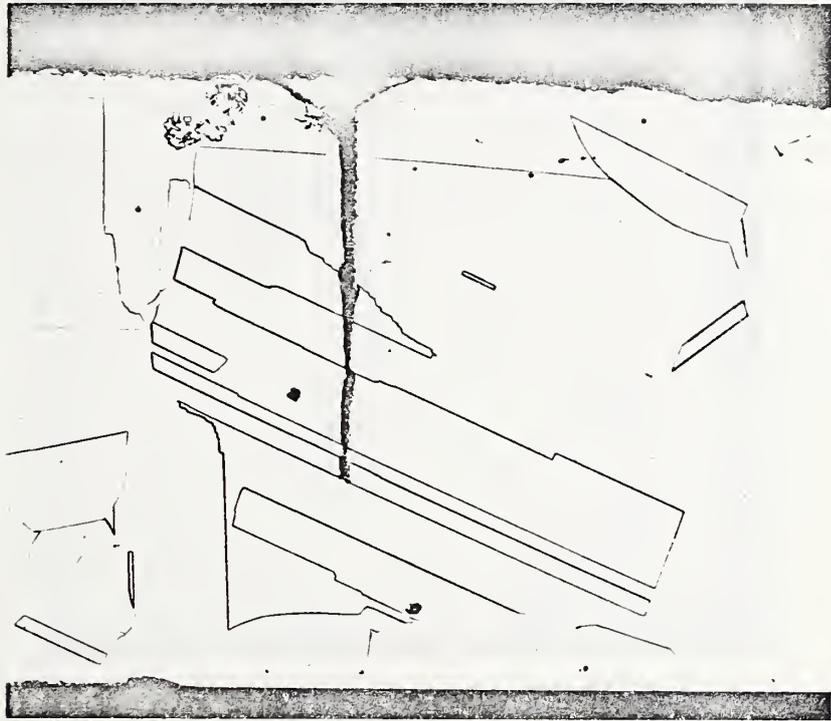
A comparison of the optical micrographs taken of cracks in this material (Fig. 5) with those observed for stress corrosion cracking of 70-30 brass in non-tarnishing aqueous ammonia solution show the morphology of cracking to be quite similar (Fig. 7, from (4)). Furthermore, the particular heat treatment of this brass which resulted in the large grain size (Fig. 5)

would be expected to cause an increase in susceptibility to stress corrosion cracking (5).

Fig. 5 Optical Micrograph (x200) of a cross section of the flexible brass tubing, etched in 1 part water (H_2O), 1 part hydrogen peroxide (H_2O_2), and 1 part concentrated ammonium hydroxide (NH_4OH), showing the metal microstructure. Cracks are predominantly transgranular.

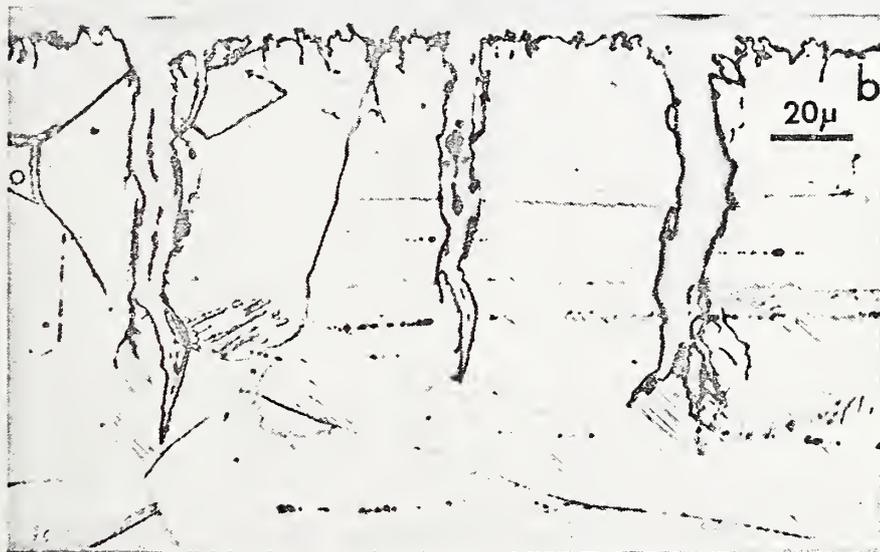
Fig. 7 Optical Micrograph showing stress corrosion cracks in 70-30 brass exposed to aqueous ammonia solution (from (3)).

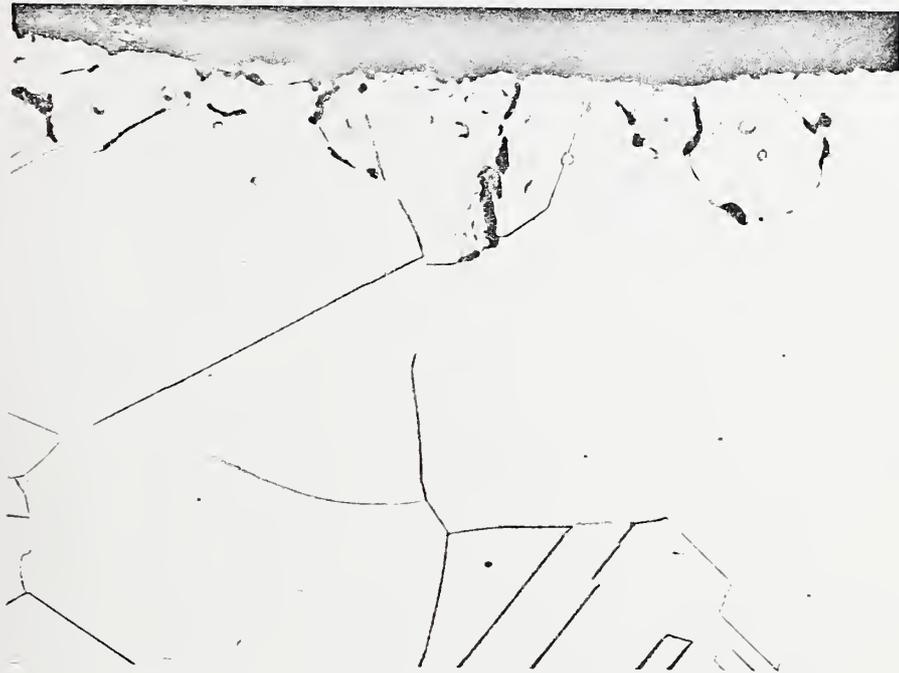
Finally, a test specimen was cut from a section of the brass tubing, bent once to simulate treatment during installation of the coupling unit, dipped into a sample of the leak detector solution, then placed into a sealed glass container. The test exposure was allowed to proceed for two weeks, after which the specimen was removed, sectioned, and mounted for metallographic examination. Although the extent of crack propagation is less than that in the failed specimens, the initial stages of cracking are evident in Fig. 8. It should be remembered that service failures were reported to have taken from 3 to 6 weeks to occur, while the short term laboratory test was all that was possible, within the time limitations set to prepare this report.

Fig. 8 Optical Micrograph (x500) of the cross section of a 5 cm specimen of brass tubing exposed for two weeks to the leak detector solution, then etched as in Fig. 5, showing initiation of cracking at the metal surface.
